Assessment of Dam Safety

Coal Combustion Surface Impoundments (Task 3)

Northern States
Power Company

Sherburne County
Power Station

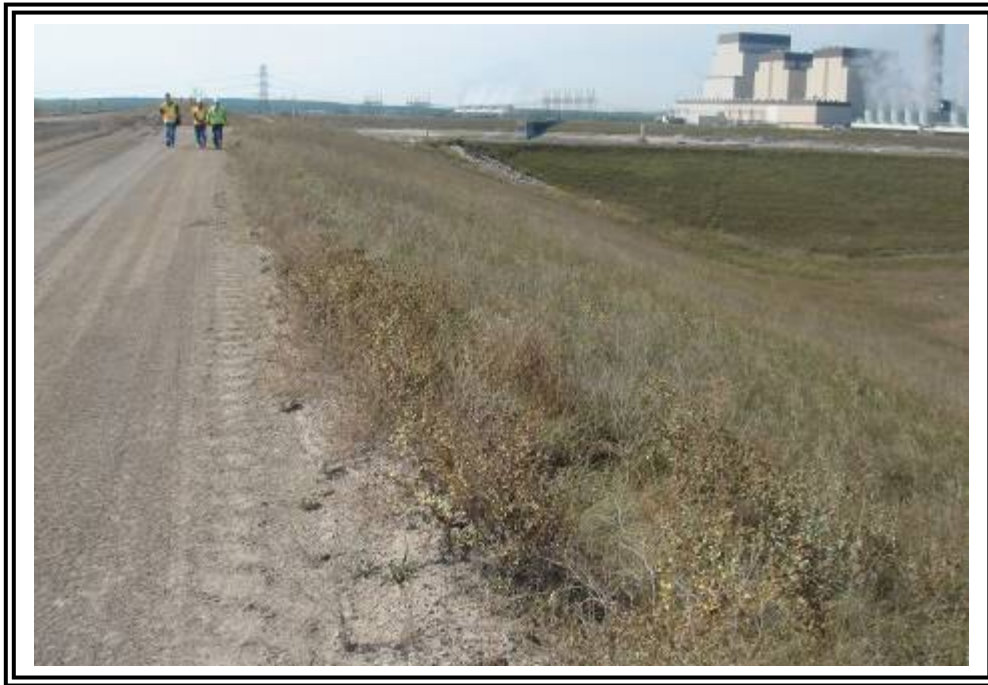
43

Downstream embankment slope of North Dam, looking northwest.

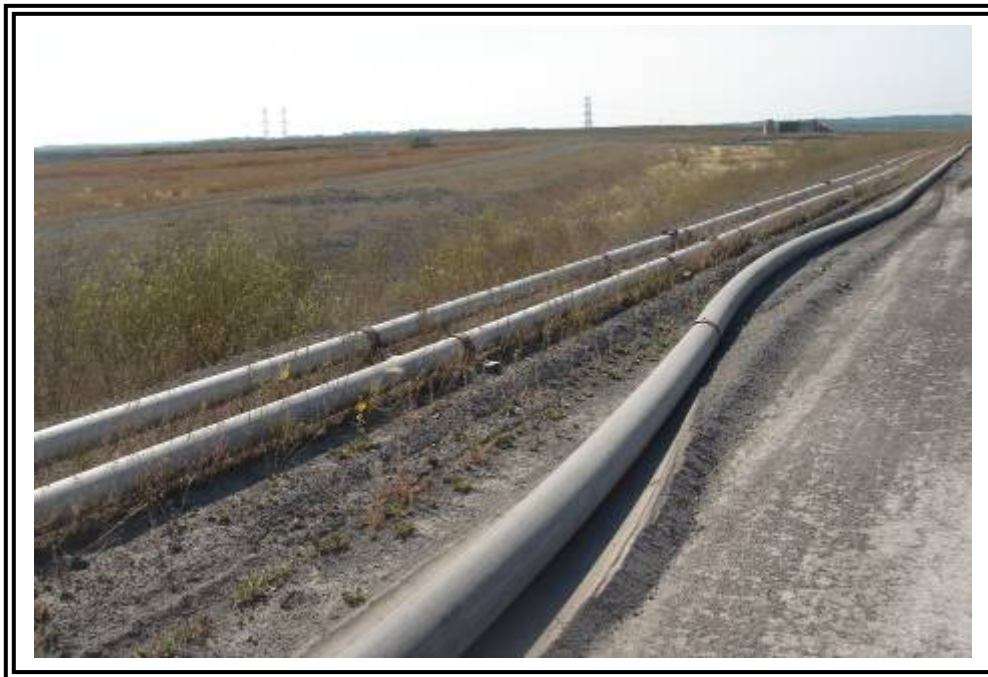
44

Partially filled portion of Pond 2, facing southwest.

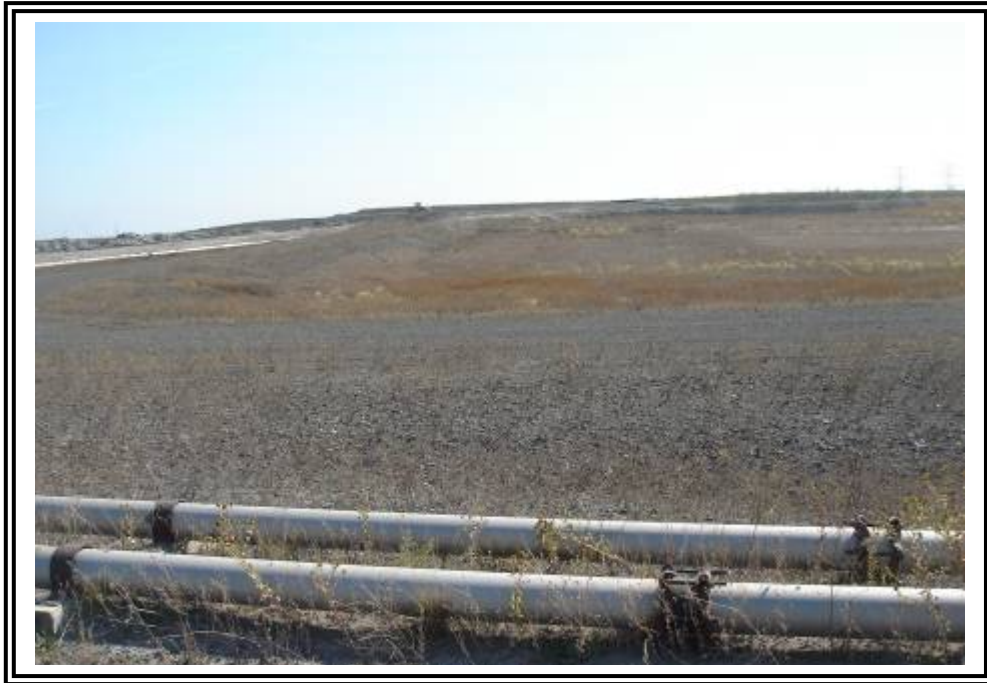
45

Partially filled portion of Pond 2, facing south.

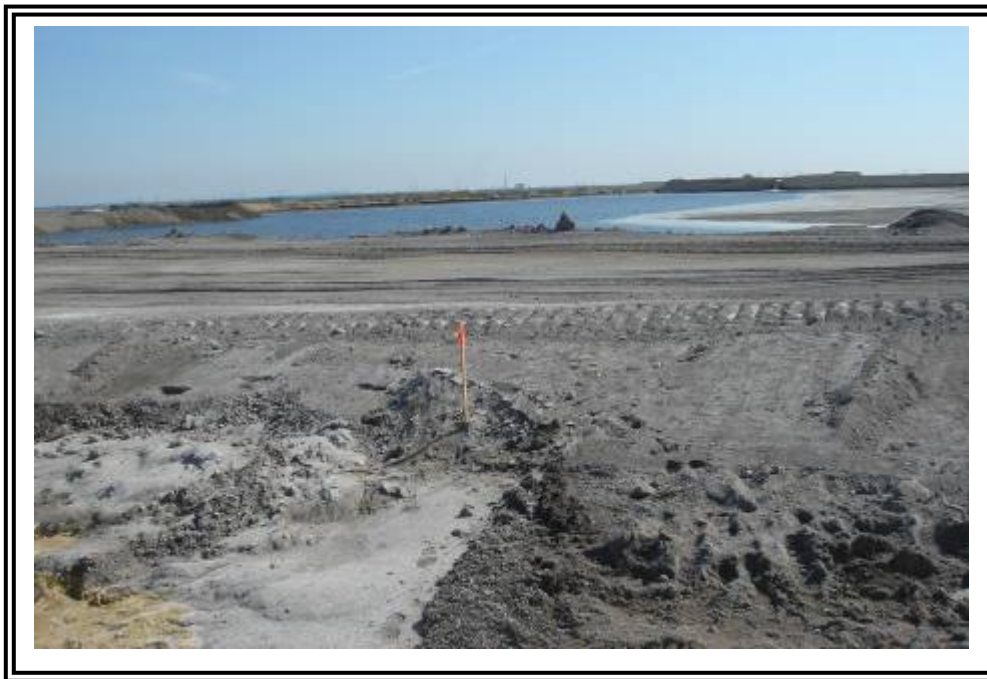
46

Active portion of pond, facing south.

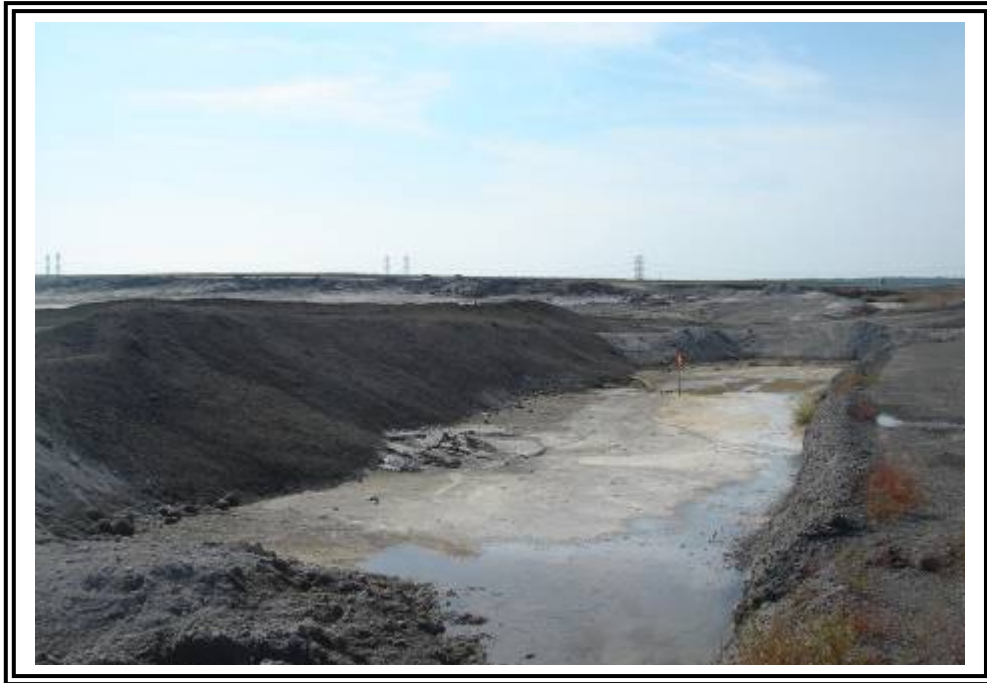
47

Pond No. 2 contains a temporary interior dam which was measured to be approximately 17 feet wide. The freeboard measured approximately 1.5 feet. Erosion was observed along the interior dam slope.

Temporary Dam in Pond 2, facing south.

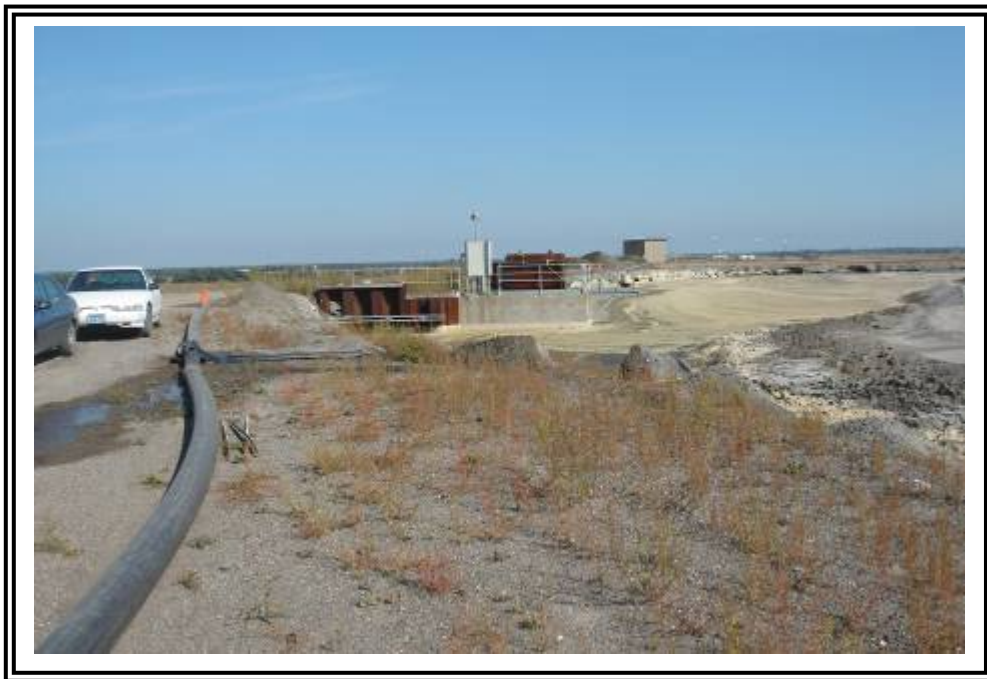
48

Outlet structure for Pond 2, facing east.

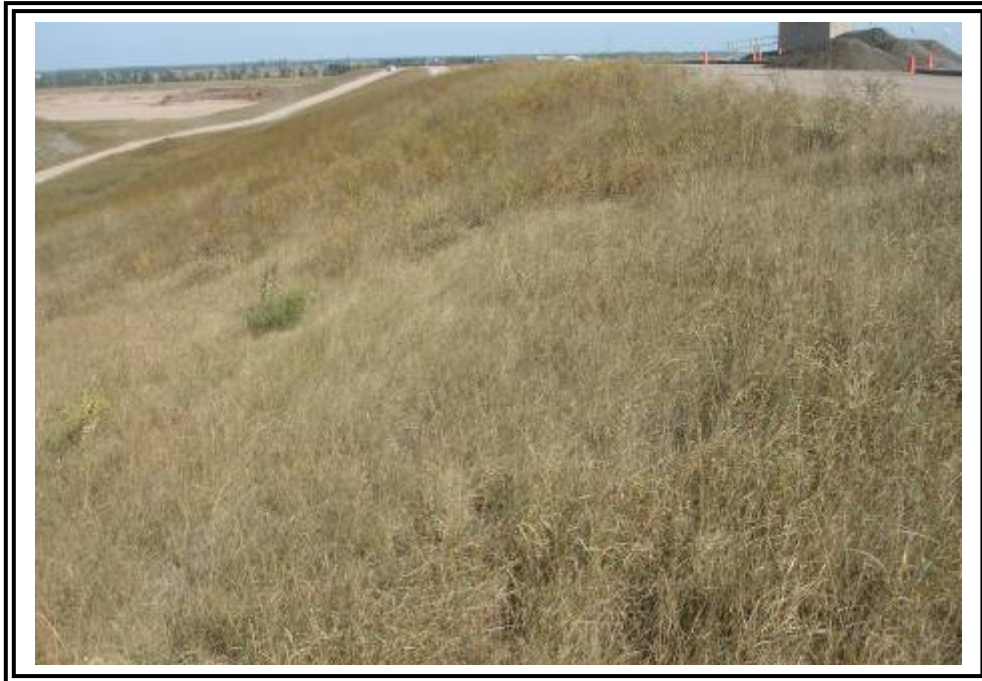
49

Downstream embankment slope of North Dam, facing east.

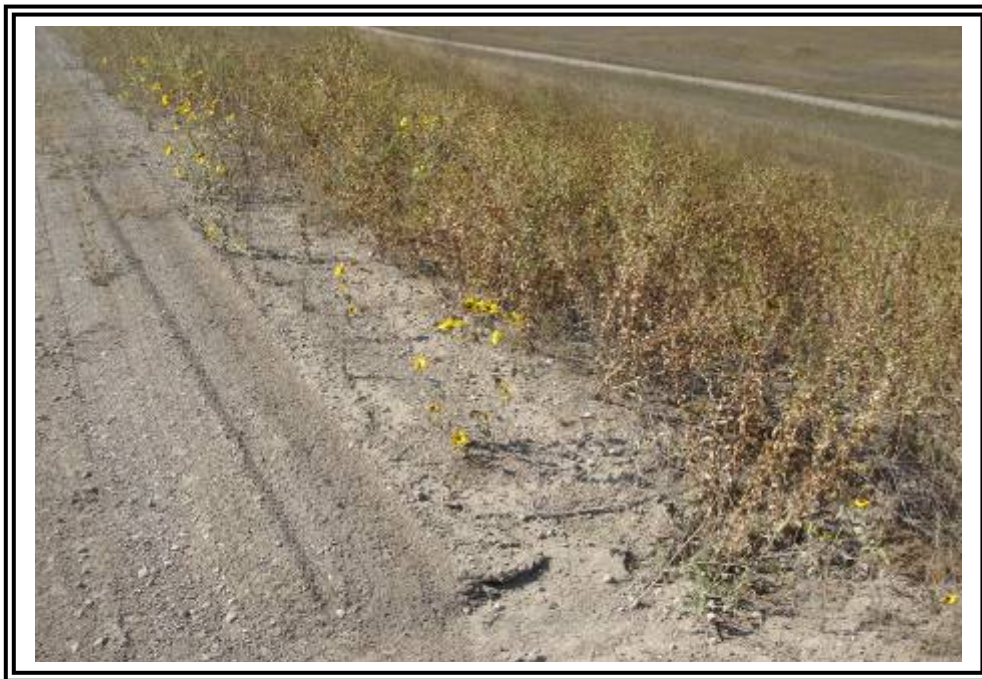
50

Minor erosion at top of downstream embankment of North Dam, facing northwest.

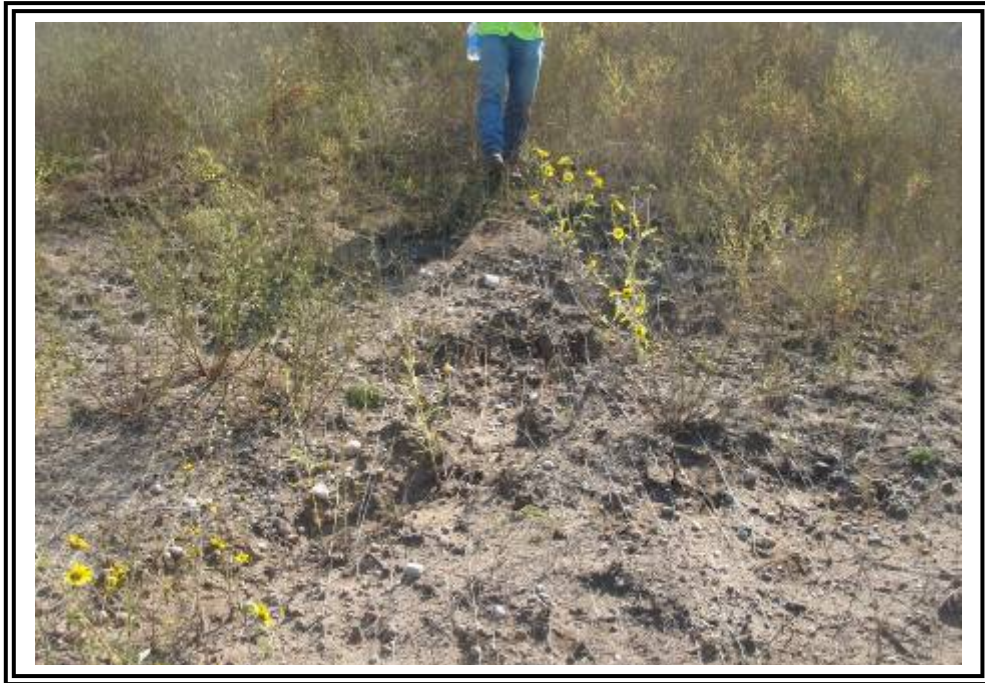
51

Minor erosion on downstream embankment slope of North Dam.

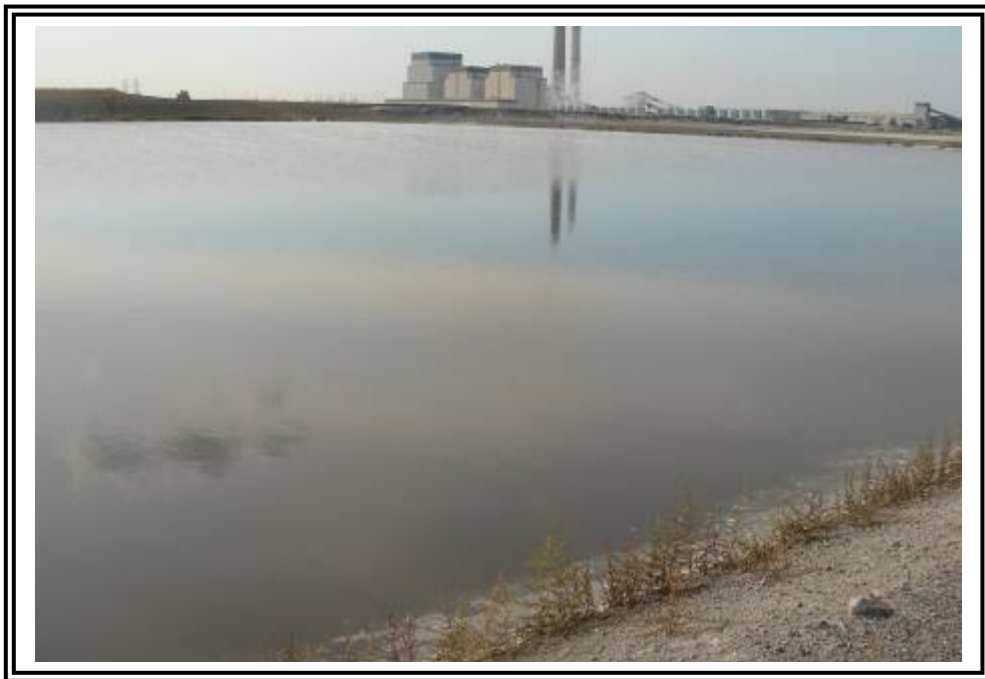
52

Looking across Pond 2 from Temporary Dam, facing northwest.

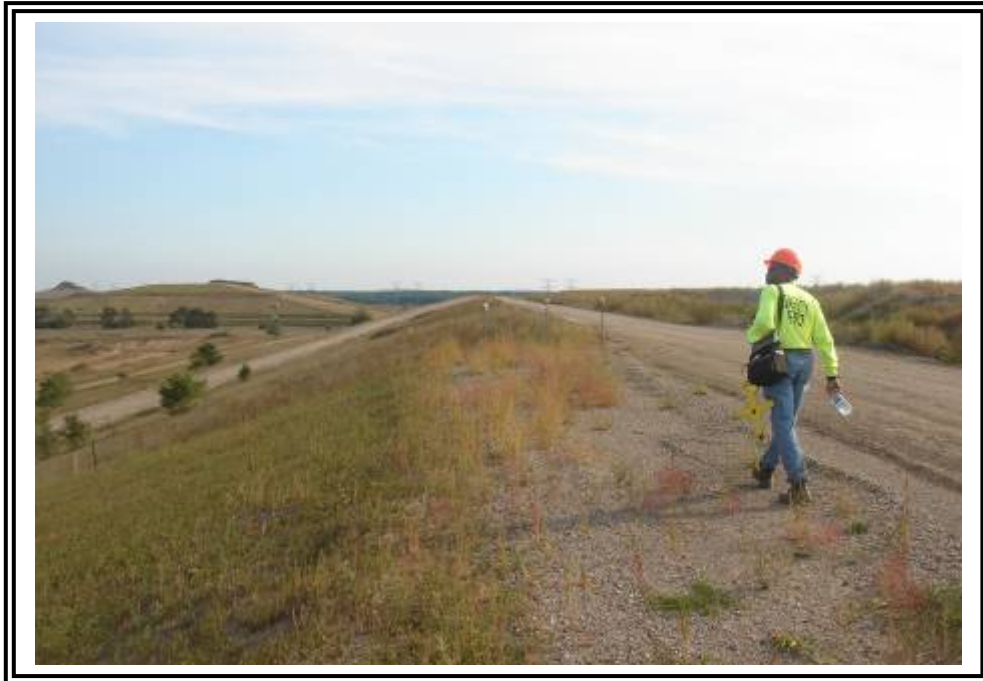
53

Downstream embankment slope and crest of East Dam adjacent to Pond 3S, facing south.

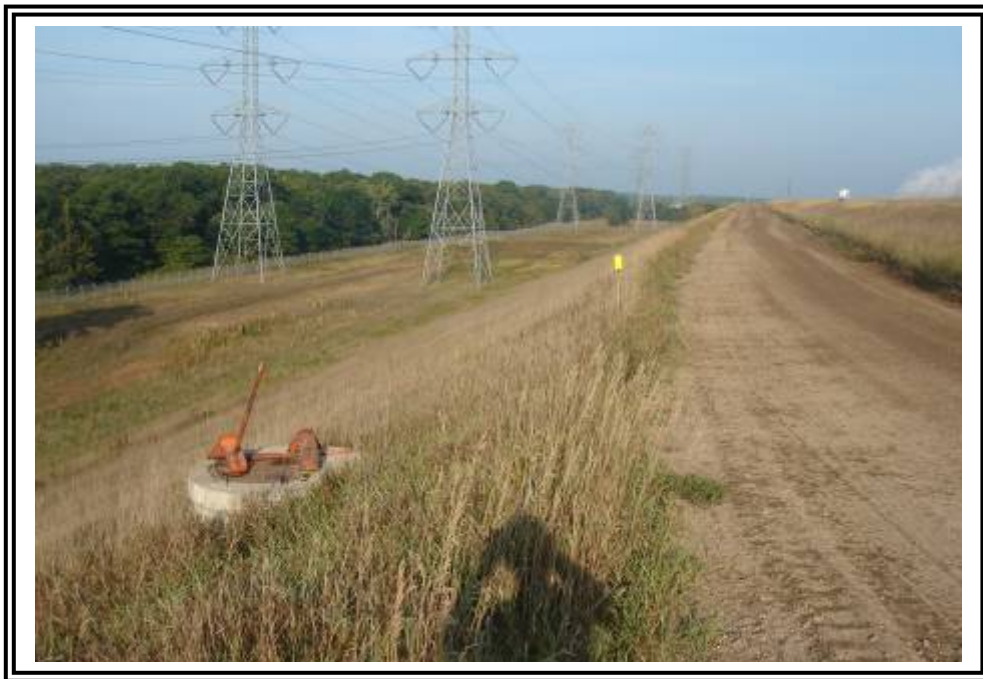
54

Downstream embankment slope and crest of South Dam, facing west.

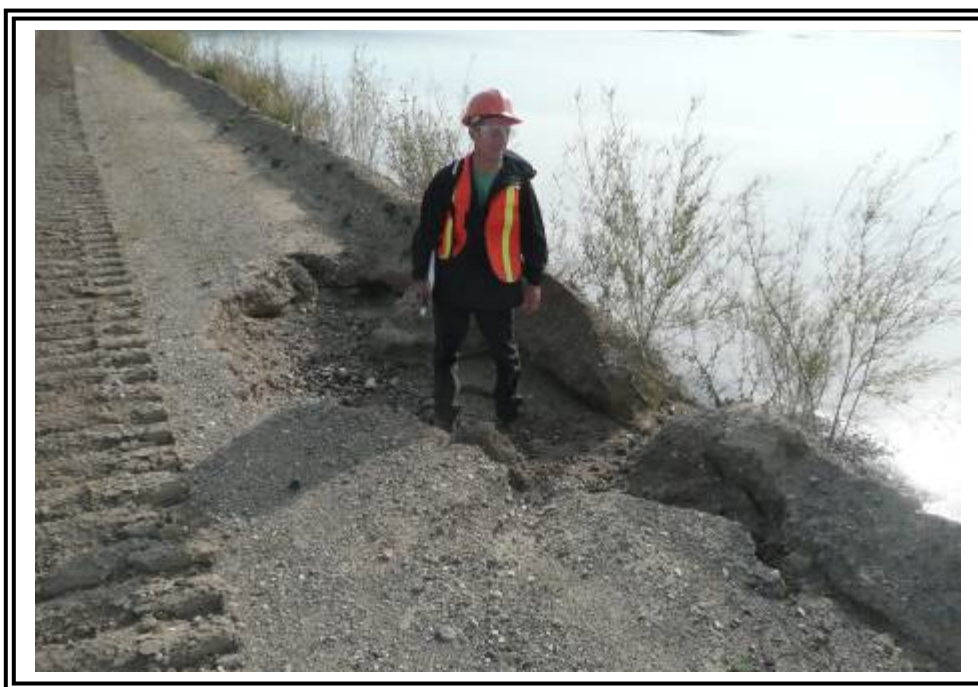
54A

Erosion of Pond No. 2 upstream embankment, facing south west.

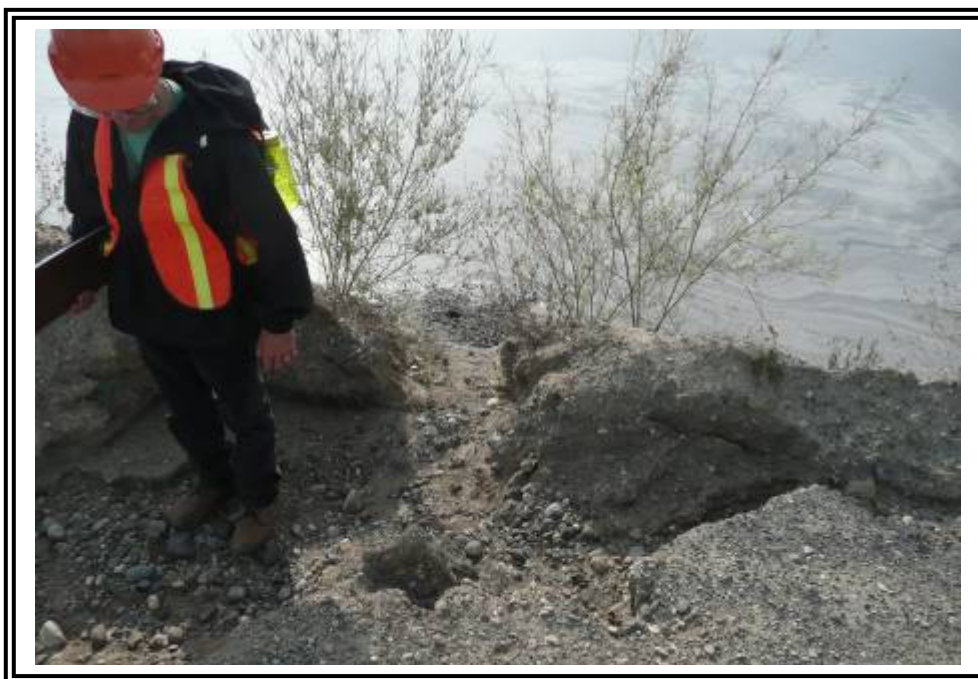
54B

Erosion of Pond No. 2 upstream embankment, facing west.

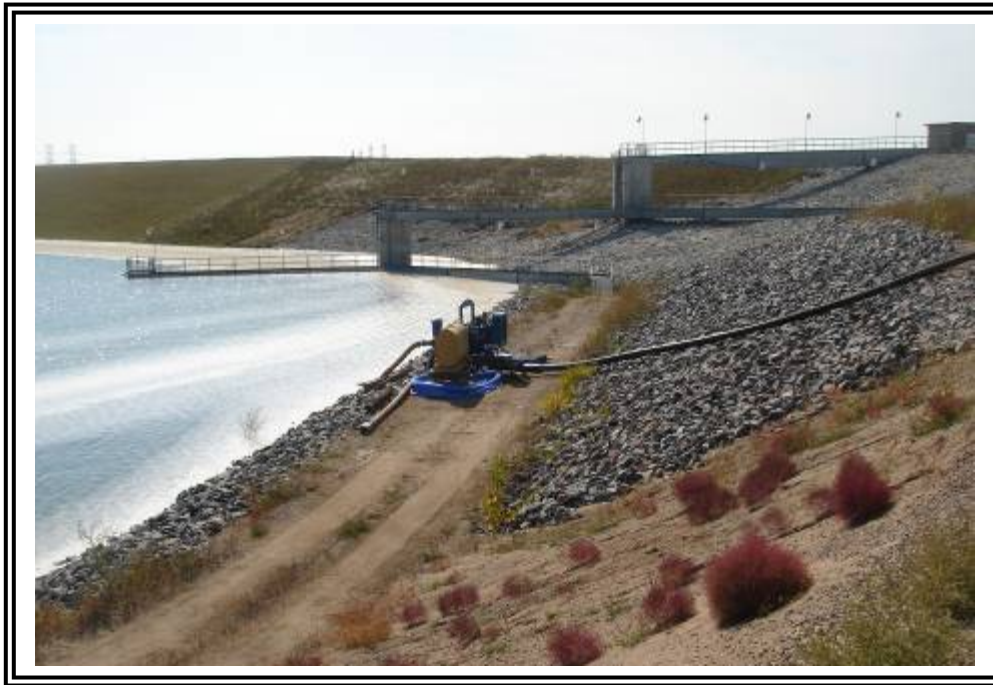
55

Upstream slope of North Embankment and outlet works, facing west.

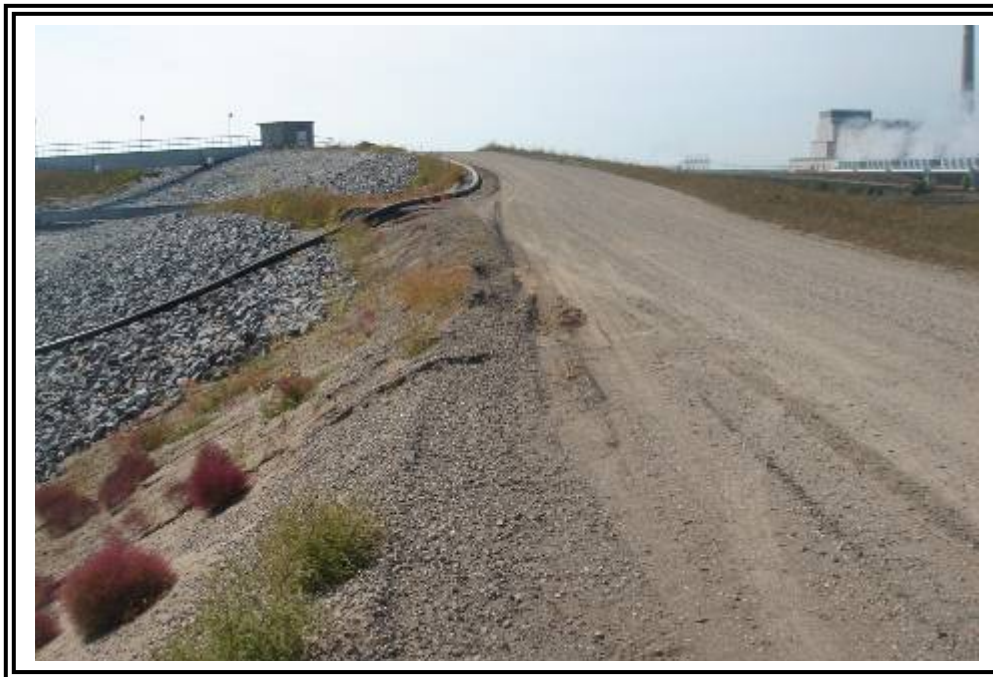
56

Upstream slope and crest of North Embankment, looking west.

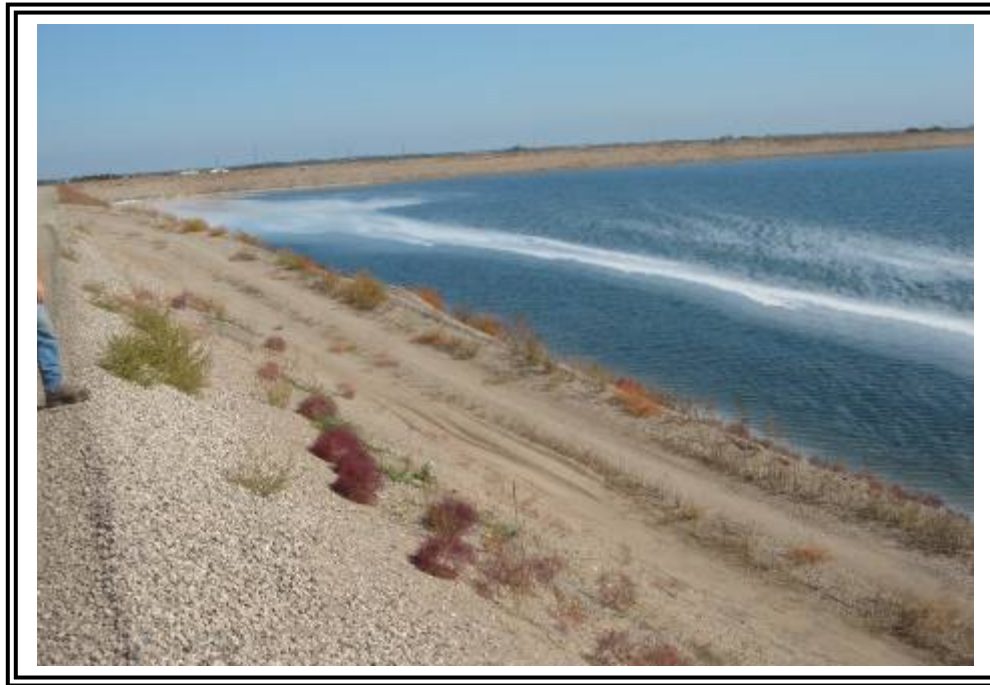
57

Upstream slope of North Embankment, facing east.

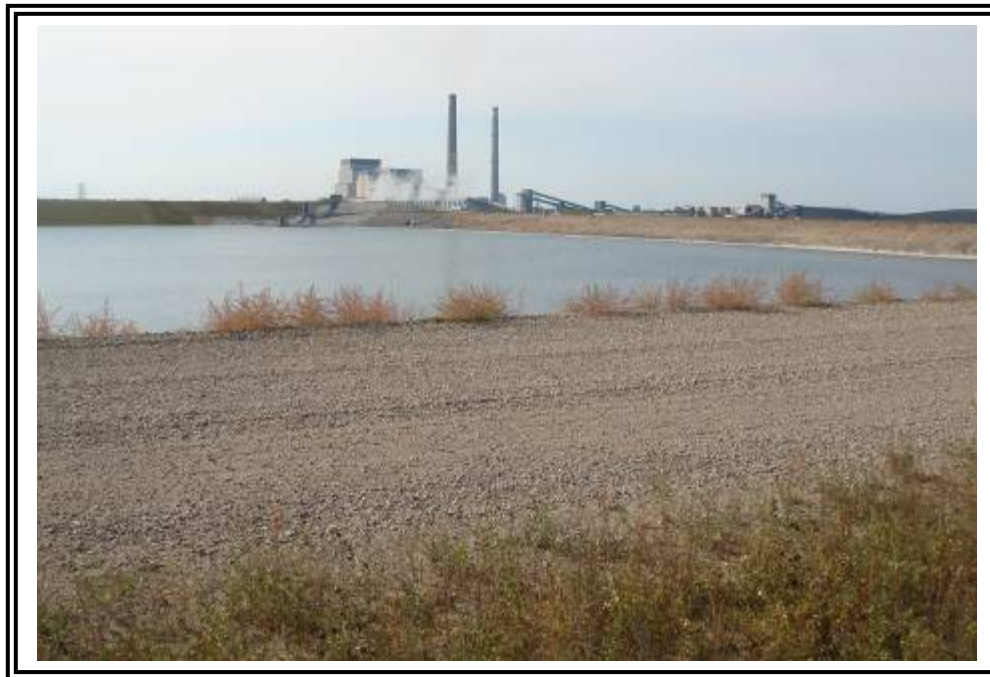
58

Looking across Pond 3N at the upstream slope of the North Embankment, looking northwest.

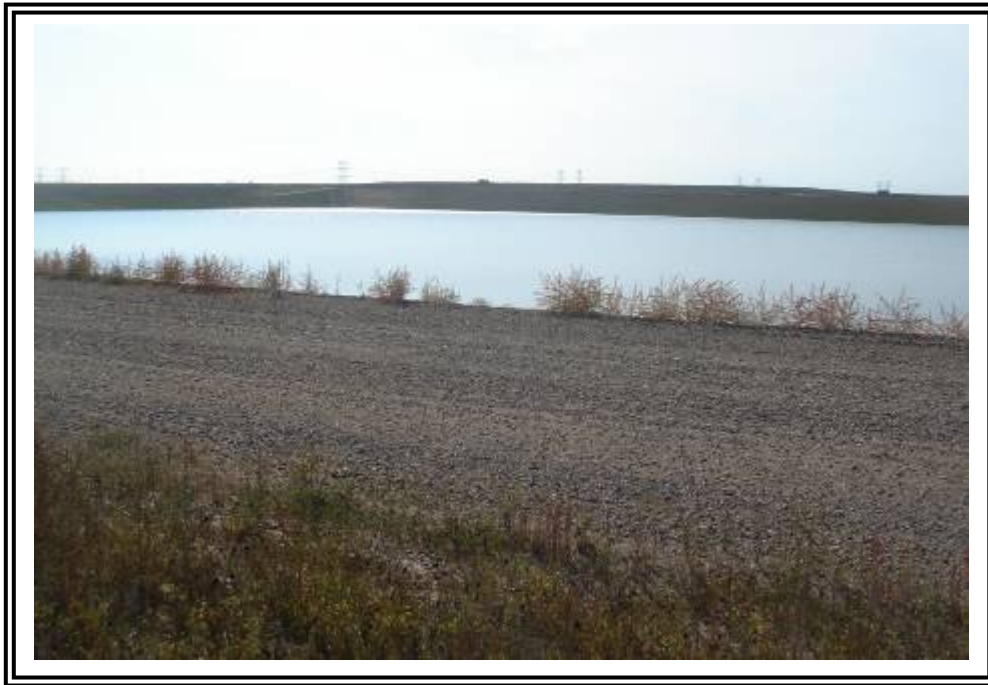
59

Looking across Pond 3N at the West Side Slope, facing southwest.

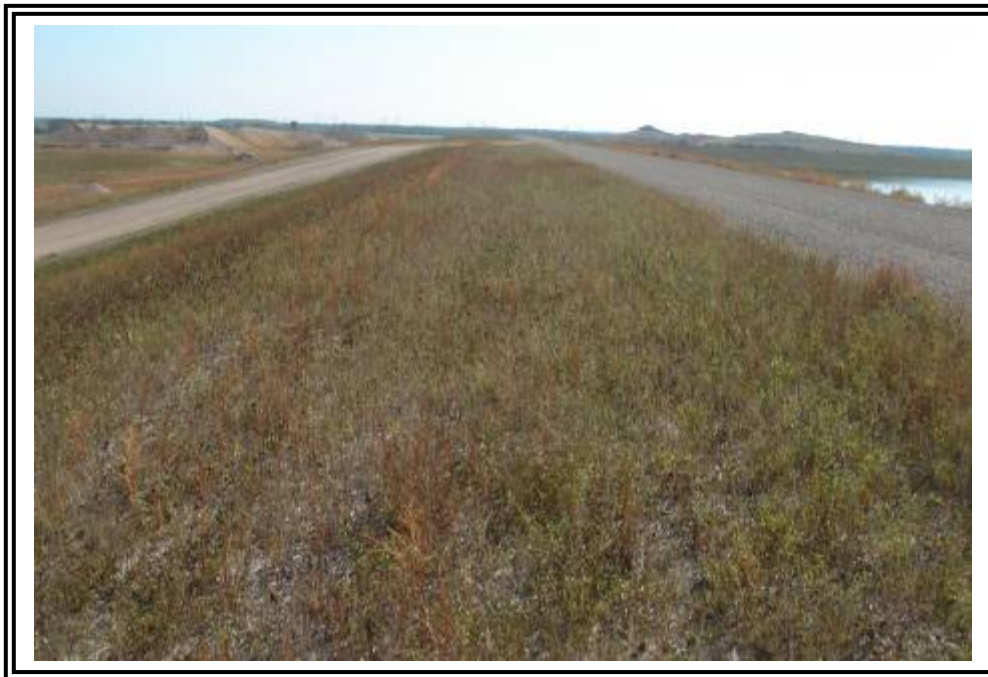
60

Downstream slope of East Embankment, looking south.

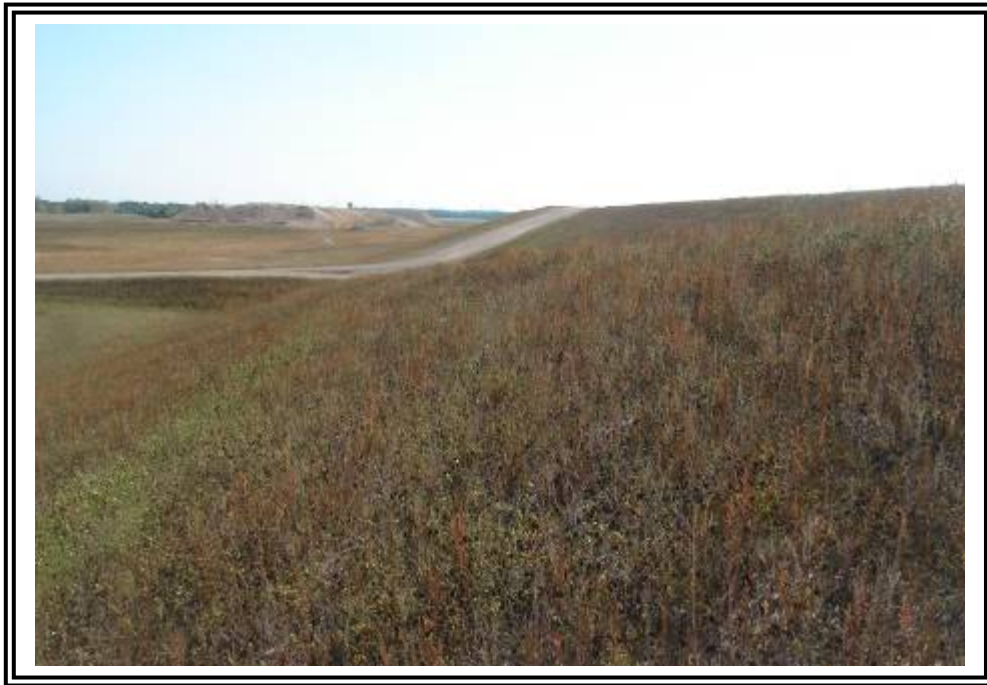
61

Downstream slope of East Embankment, facing south.

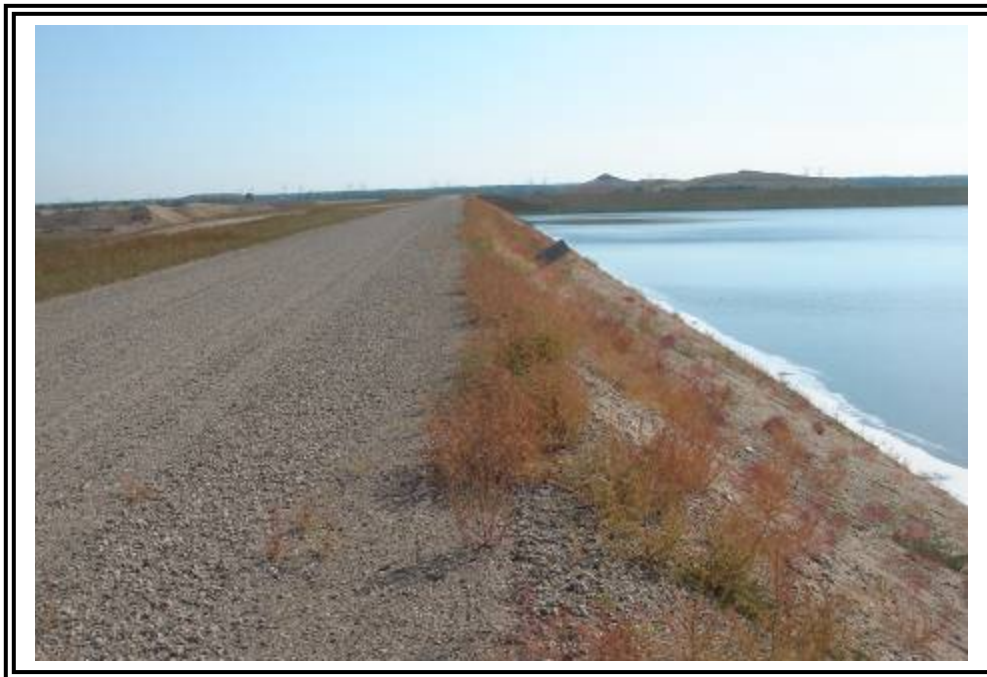
62

Crest and upstream slope of East Embankment, facing south.

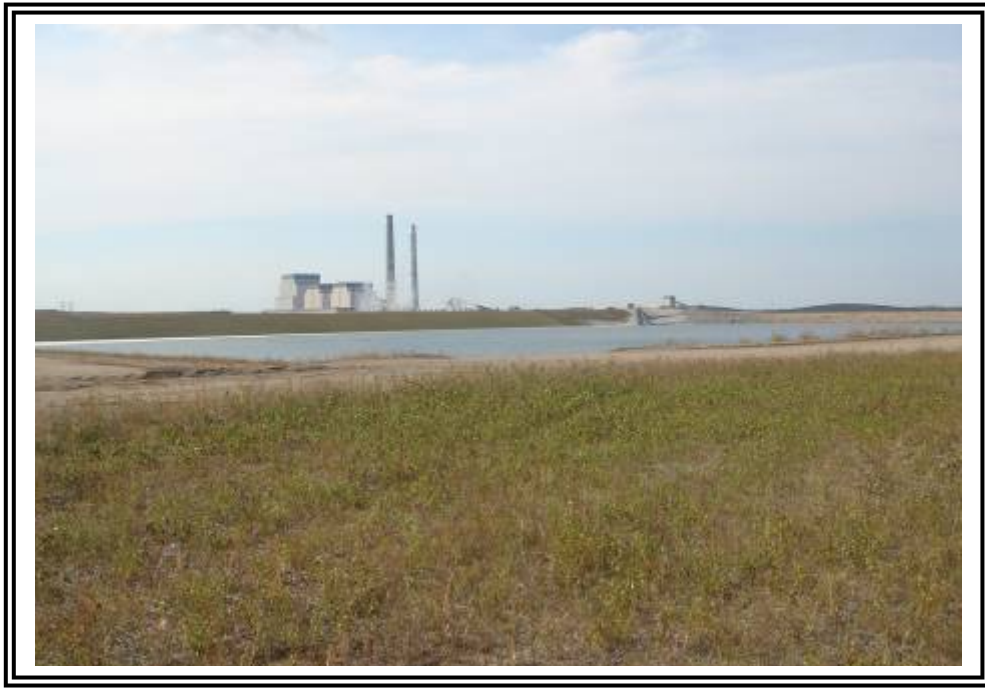
63

Looking across Pond 3N at West Side Slope, facing northwest.

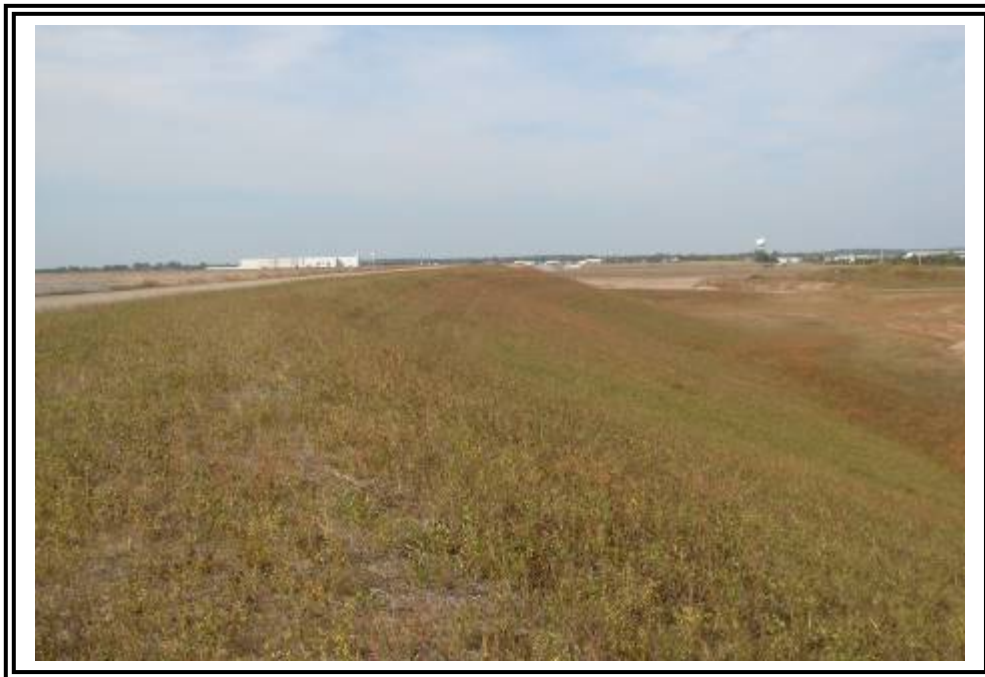
64

Downstream slope of East Embankment, facing north.

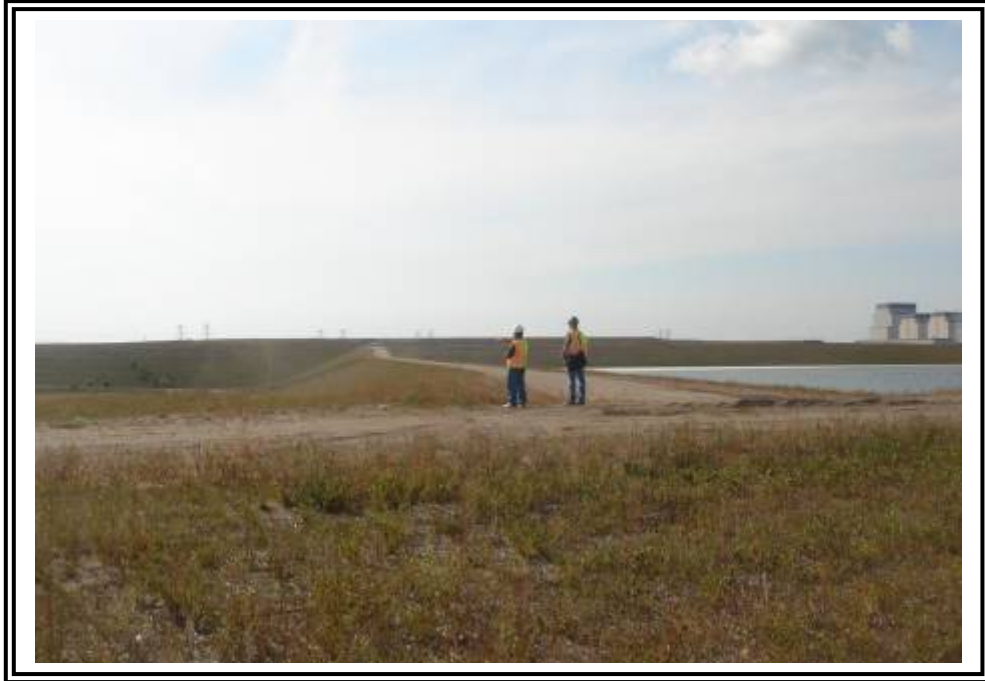
65

South Embankment of Pond 3N which separated Pond 3N and 3S.

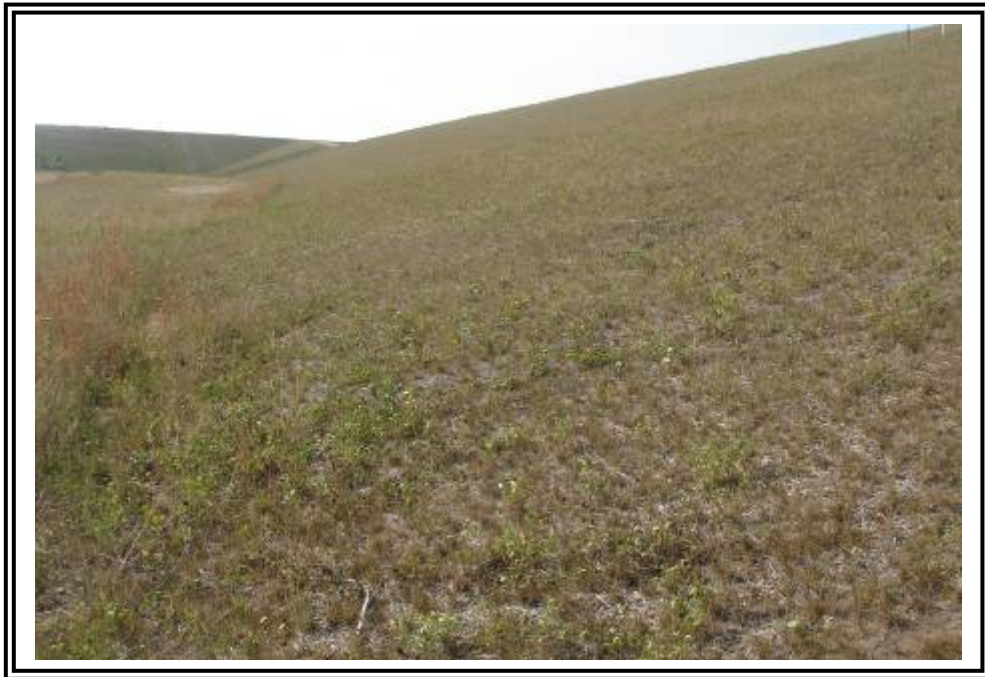
66

Downstream embankment slope of Dam between Pond 3N to Pond 3S, facing west.

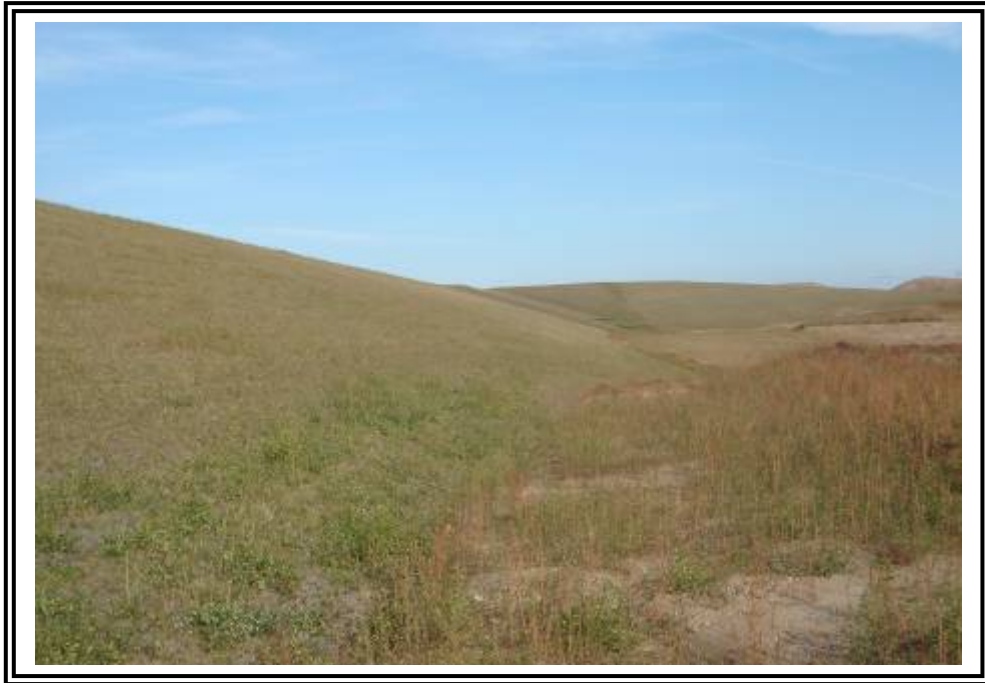
67

Downstream slope of Embankment between Pond 3N to Pond 3S, facing east.

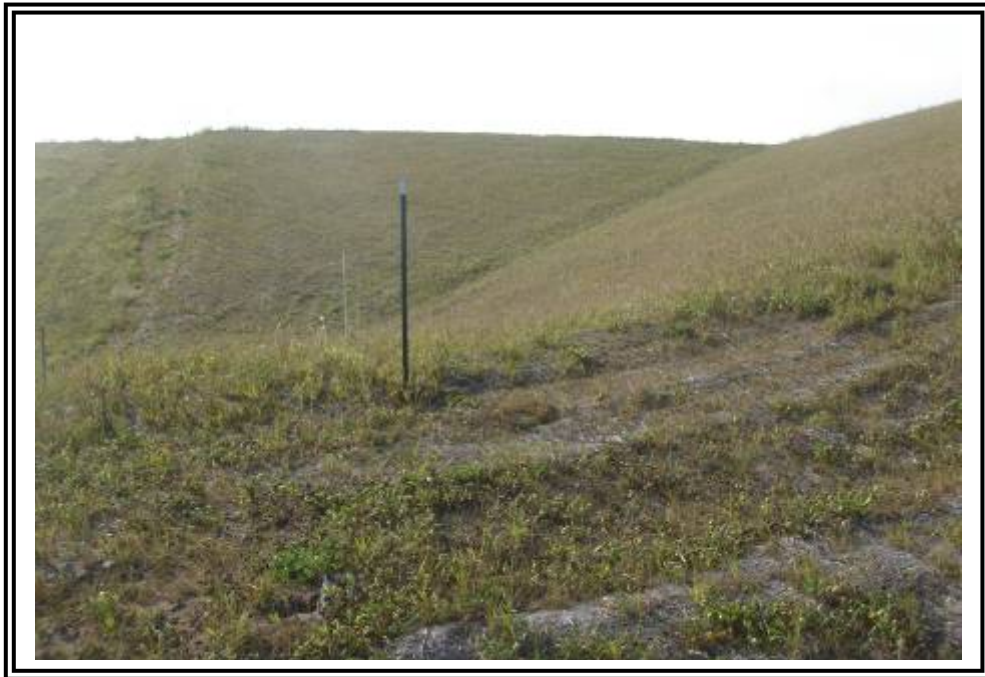
68

Groin at Ponds 3S and Pond 2, facing west.

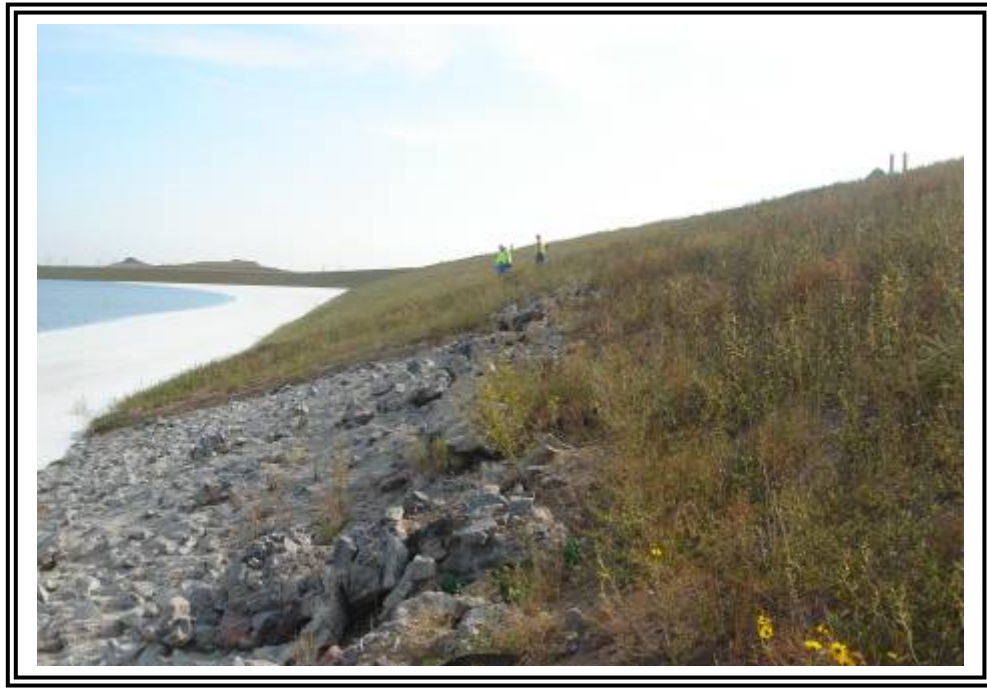
Upstream slope of Embankment between Pond 3N to Pond 2, facing south.
